# Rust affects car crash safety

10 April 2018

*Villaägarna (Swedish Homeowners' Association) and Folksam Insurance have completed the world's first official Euro NCAP crash test of used and rusty cars. The results show that serious rust on the crash beams impairs crash safety. Used and rusty Volkswagen Golf and Mazda 6 cars were used in the test.*

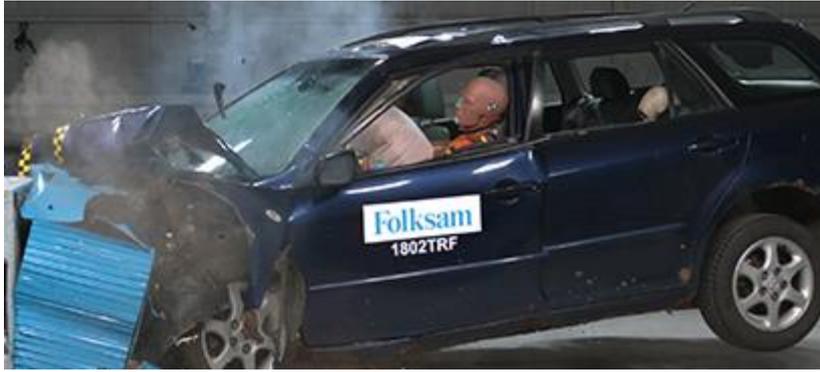
After hitting the steering wheel airbag, the driver crash test dummy rebounded and hit its head hard against the pillar between the car doors (B-pillar). However, the Euro NCAP assessment does not take this into account. When the Mazda 6 was new, this wasn't an issue as the crash test dummy's head hit the headrest on the rebound. But in the used car, the course of the crash develops very differently. As a result of considerable deformation, the driver's seat folds towards the side window and the B-pillar, and the crash test dummy hits its head.

*You can see here how the seat and the headrest are pressed toward the B-pillar.*
