# Rust affects car crash safety

10 April 2018

*Villaägarna (Swedish Homeowners' Association) and Folksam Insurance have completed the world's first official Euro NCAP crash test of used and rusty cars. The results show that serious rust on the crash beams impairs crash safety. Used and rusty Volkswagen Golf and Mazda 6 cars were used in the test.*

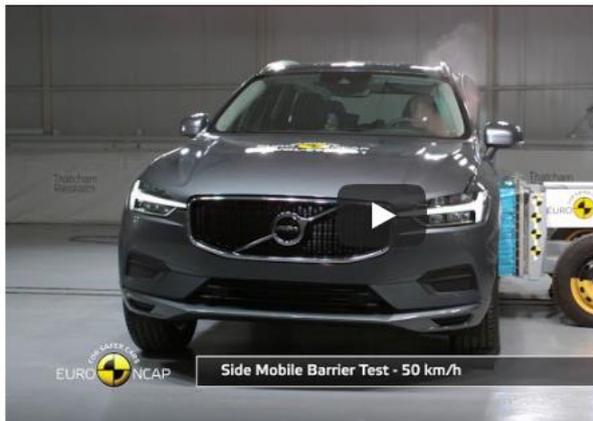
**An example of how such a curtain airbag triggered by a frontal collision works in a frontal collision**

So in frontal or diagonal collisions, this will reduce the risk of hitting the head on the B-pillar after a rebound from the steering wheel airbag.
